THE QUEST FOR THE MISSING SEVEN DECIBELS

Joergen Heiden

Grontmij | Carl Bro A/S
Acoustica - department
Dusager 12, 8200 Aarhus N, Denmark
jorgen.heiden@grontmij-carlbro.dk

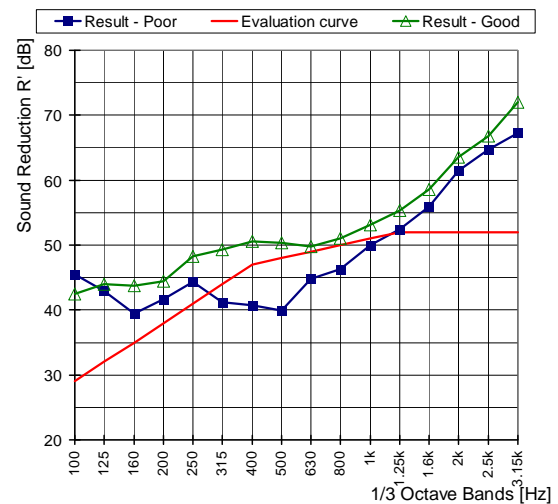
The results for the pour wall showed a typical loss of sound insulation in the mid frequencies (around 500 Hz – see figure 1). This is due to some kind of mechanical interaction between the two wall parts.

Figure 1. Initial sound insulation of walls

The search for stiff connections started at the top of the building and got us through the entire wall before the error(s) was located in the foundations, where some unusual construction details were found. Unfortunately it was almost impossible to correct. In stead a rather simple solution with gypsum boards added directly to the existing wall surfaces succeeded in achieving $R'_w \geq 55 \text{ dB}$.
