THE QUEST FOR THE MISSING SEVEN DECIBELS

Jørgen Heiden

ABSTRACT

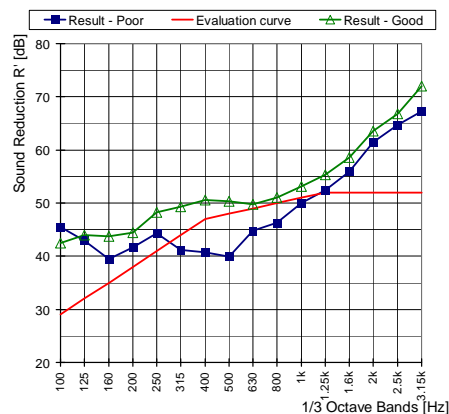
In connection with the handing-over procedure Acoustica did some random tests of the sound insulation at a housing estate consisting of 25 terraced houses. All constructed with party walls built as a double wall of two 100 mm cellular concrete with a 90 mm cavity filled with (soft) mineral wool. The sound insulation R'_w and the impact level $L'_{n,w}$ were measured for two party wall samples. The impact level did for both measurement meet the demands in the building regulations ($L'_{n,w} \leq 53$ dB). The sound insulation measurements showed one good result and one poor (see figure 1). The poor sound insulation was only $R'_w = 48$ dB (demand $R'_w \geq 55$ dB). The poor result shows a clear indication of a rigid connection between the two wall parts.

Figure 1 – *Initial sound*

insulation results for the two

samples

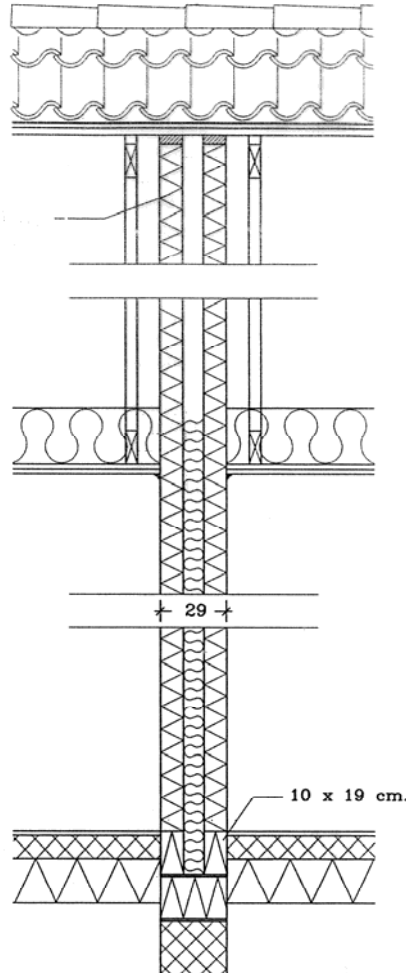
Construction drawings were provided by the civil engineer (see figure 2). The foundation of the two wall elements is separated – not entirely as described by the supplier of wall material, but the deviation was not expected to give a loss of 7 deciBels. There seem to be the following possibilities of rigid connections:

- a) The roof detail indicates that the laths connect the wall parts.
- b) The wall could be erected using binders between the wall parts.
- c) Mortar “bridges” under the walls could connect the wall parts.

Figure 2 – Construction drawing of the party wall

The laths did bridge the two wall parts. All the laths were then cut and a new measurement of R'_w was done. Result $R'_w = 49$ dB – well within the measurement uncertainty. The conclusion was that this was not the sole fault – but possible one of more.

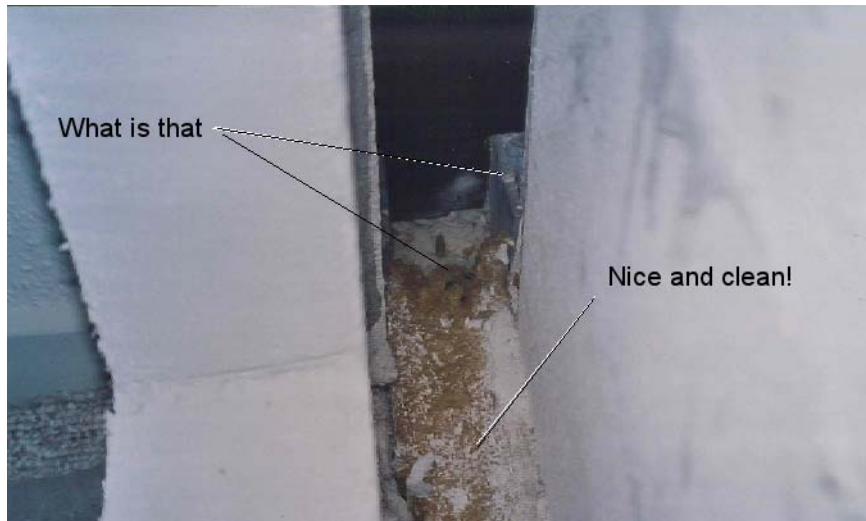
In order to check for mortar bridges a piece of the party wall was cut out. The sight was surprising – see figure 3. There were no mortar bridges, but some untold steel profiles revealed themselves. Because the entire foundation was covered by a radon sheeting the civil engineer was afraid that the house should slide off the foundation. Therefore all four corners were fixed by an L-steel bar embedded deep down in the foundation. In the party wall two of these steel bars were placed just opposite each other. According to the design project these profiles should only be embedded from 200 mm below the cellular concrete and down. Actually they had been embedded up to the top of the foundation. This certainly looked like the cause of the troubles. The conclusion of the three initial investigations was that the problems lied in the foundation of the double wall. As the cost for correcting the problem in what have shown out to be 17 out of 20 party walls could be imposed either on the civil engineer or on the contractor, it was mandatory that the cause of the problem was identified as precisely as possible.

Figure 3 – Picture of the cavity - towards the façade

At first the erected building was brought in accordance with the design project by cutting away the concrete “plug” between the steel bars (to the designed depth of 200 mm). This was done from outside the façade using a special chain saw. This step resulted in a reduction of sound insulation back to the initial level of $R'_w = 48$ dB!

Did the steel bars form a “tuning fork” strong enough to result in a rigid connection of the wall parts? In order to investigate this a deep horizontal cut was made through the façade foundation – deep enough to cut both steel bars (see figure 4). This resulted in an increase of R'_w to 49 dB.

It turned out that there was a difference between small rooms (width less than 40% of the entire party wall) and large rooms (entire party wall). For the small room it was enough to add gypsum boards (2 layers) on one side of the party wall. For the large room the results shown in table 1 were obtained. In all cases the gypsum boards were mounted directly onto the existing wall surface without removing the wall paper. The gypsum boards were mounted with standard screws as close as normally recommended for mounting gypsum board to frameworks etc.
